Materials can be key to differences in module durability

Defect assessment | DuPont Photovoltaic Solutions recently completed a five-year study of commercial crystalline silicon PV systems, amassing a wealth of new information about PV system field experience and PV module defects. Principal investigator Alexander Bradley discusses the findings, which, in addition to supporting the company's ongoing analysis of materials performance, are expected to provide benefits across the industry. Building on the industry knowledge pool contributes towards the standardisation of performance expectations across the solar industry, enables the development of more stringent risk mitigation techniques, and helps purchasers of solar power systems make educated and informed materials assessments

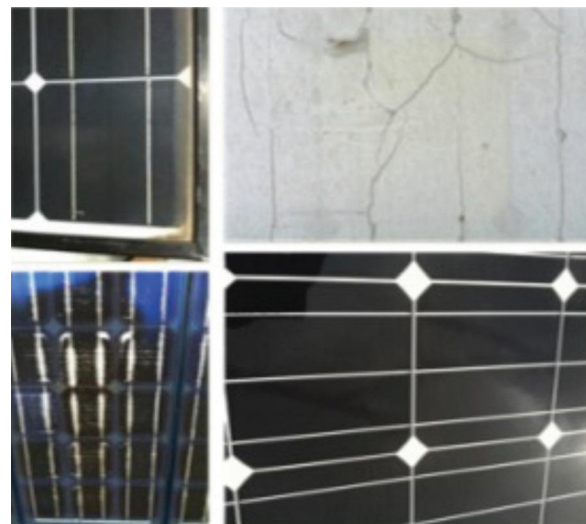
The cell may be the most valuable part of a module, but the discoloration of encapsulants and backsheets can also exact a heavy price (see Fig. 3). Discoloration can cause embrittlement of these two electrical insulating components; this in turn can lead to delamination and the loss of mechanical properties, which can compromise electrical insulation. These issues are also grounds for potential workmanship warranty claims.

Figure 3. Representative visual defects (clockwise from top left): etched glass, cracked backsheet, snail trails and encapsulant discoloration.

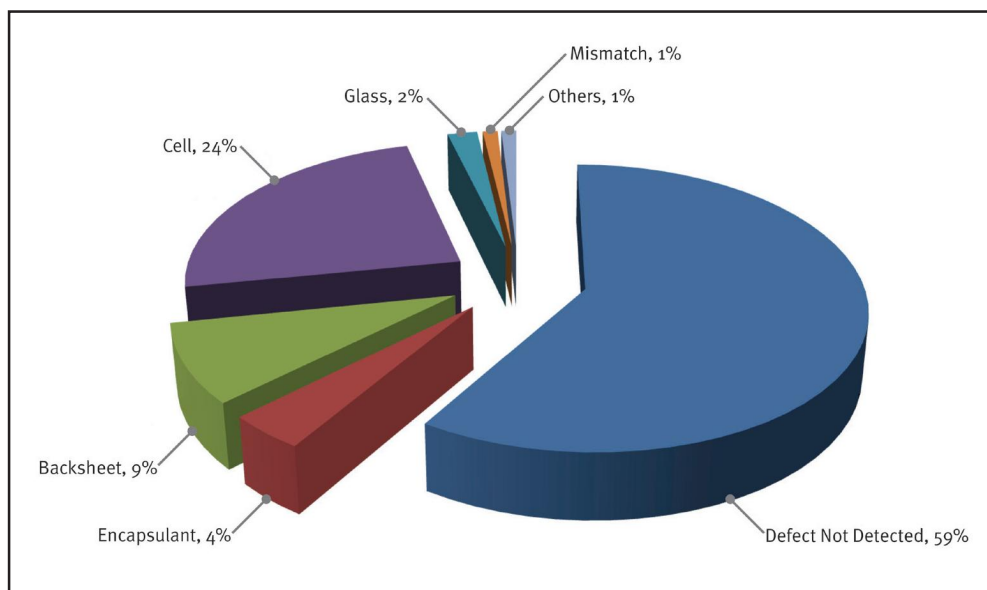
The superstrate accounted for only 2% of defects (Fig. 2). Twenty-four per cent of defects related to the cell, including hot spots (identified via thermal camera), visible corrosion, burn marks at interconnections, and cracks (identified by snail trails.) Encapsulants accounted for 4% of defects. While this percentage is low, it represents an important cause of defects, because of the resultant loss in transmission, as well as a shift in the transmission spectrum, which allows a shorter wavelength of light to penetrate the module.

Figure 2. Subcomponent visual defect percentages.

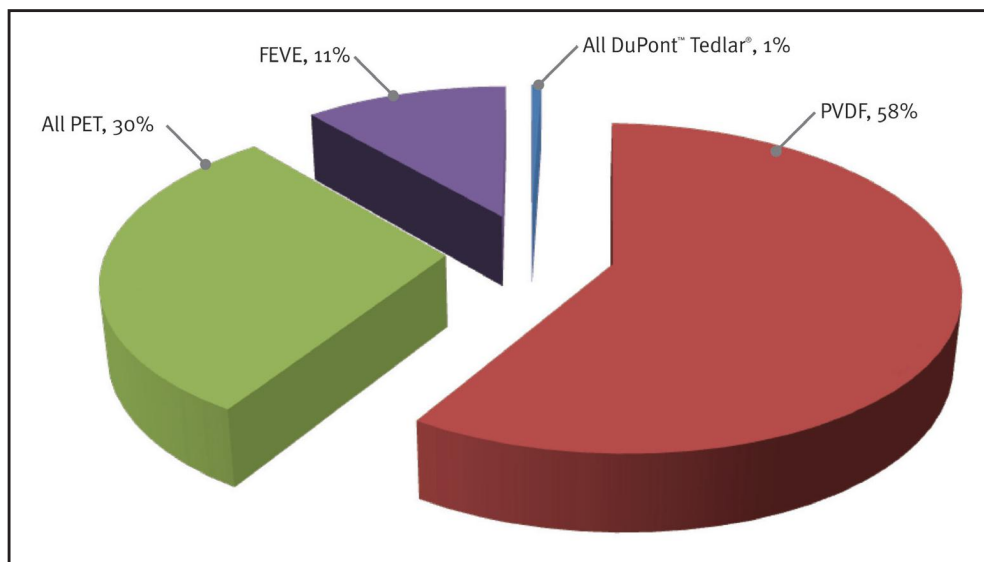
Figure 4. Backsheet visual defect percentages for different backsheet materials.

Backsheet defects accounted for 9% of the total defects, and researchers found a significant variation in the percentage of defects across different backsheet materials (Fig. 4).
