Understanding snail trails on PV modules

Module degradation | When the phenomenon of so-called snail trails first emerged over a decade ago, they prompted concerns of a major new problem afflicting PV modules. Sylke Meyer, Marko Turek, Thomas Manke, Stephan Großer and Christian Hagendorf, who have contributed extensively to understanding the science behind snail trails, review the latest thinking on the phenomenon and what it means for plant performance

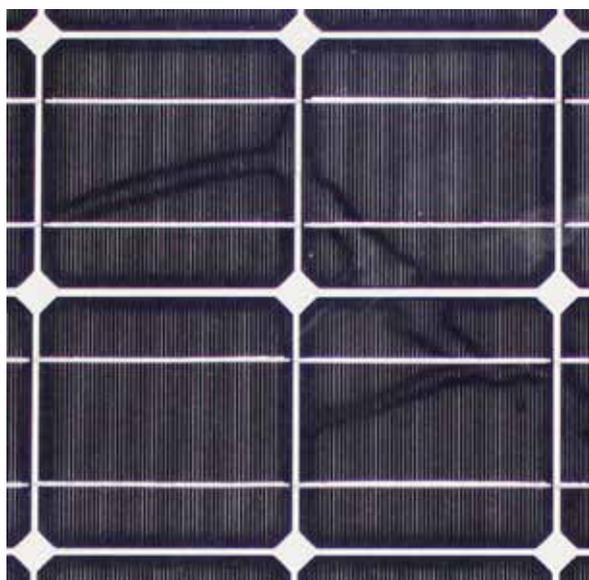
▲ **Fig. 1: Solar cells with crossing and framing discoloration**

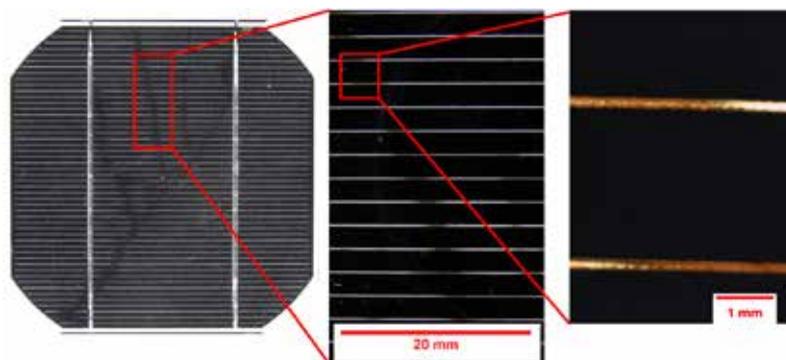
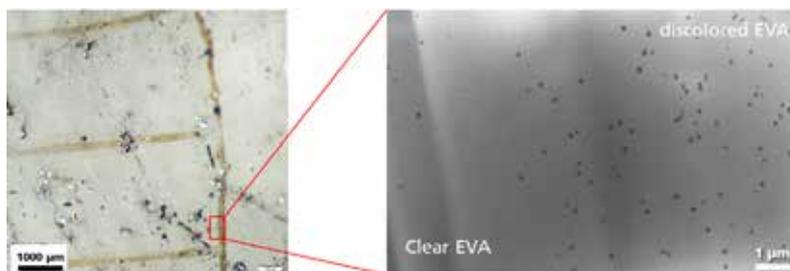
It became obvious by simple microscopic inspection of snail trail-affected module sites that the visual impression of dark stripes on the cell surface is caused by partially discoloured contact fingers. As illustrated in Figure 2, the impression of a homogeneous dark area is a kind of optical illusion since it is solely caused by a discontinuous brownish discoloration of the silver grid fingers but not the cell surface itself. Based on this very early finding it

► **Figure 2. Microscopic inspection of a typical "snail trail" discoloration, increasing zoom factor from left to right**

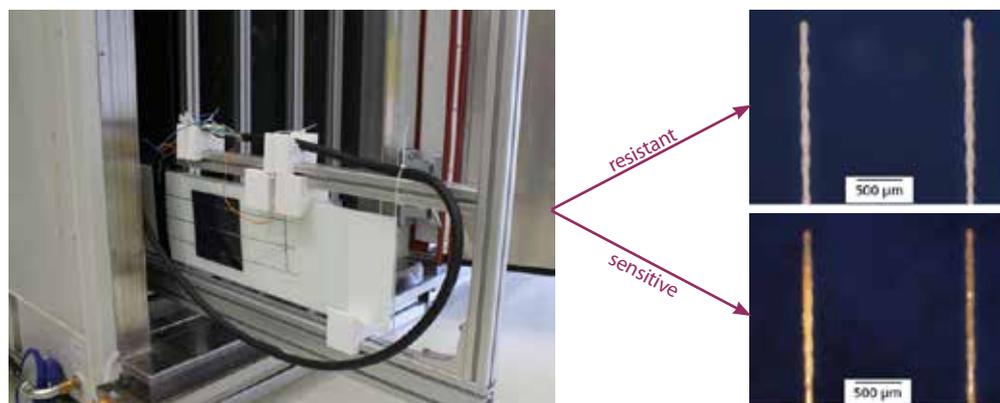
Several lab procedures have been developed to test the sensitivity of module materials for grid finger discoloration. This can be done by treatment of a one-cell mini-module with damp heat conditions under bias and subsequent microscopic inspection of grid fingers at the cell edge. As shown in Figure 5, a clear difference can be observed between samples which are sensitive to or resistant against grid finger discoloration after damp-heat treatment for 1,000 hours. In this example, the samples were different only in their foil materials (encapsulant and back sheet) but contained the same type of cell. This shows that the solar cell itself or the type of silver paste is of minor influence. The mini-module test is very useful for module manufacturers in order to qualify their foil materials with respect to grid finger discoloration. Therefore, there is an actual SEMI activity to standardise this kind of test (SEMI SNARF Document #6071). Unfortunately, this test principle is not fully applicable for standard-sized modules. It turned out in experiments that for standard modules not all sensitive material

Figure 5. Test setup for mini-module samples and test results. If the colour of the grid finger remains unchanged after 1,000 hours test duration the material combination can be regarded as resistant to grid finger discoloration. In contrast, a significant brownish colour of grid fingers at the cell edges indicates sensitive foil materials

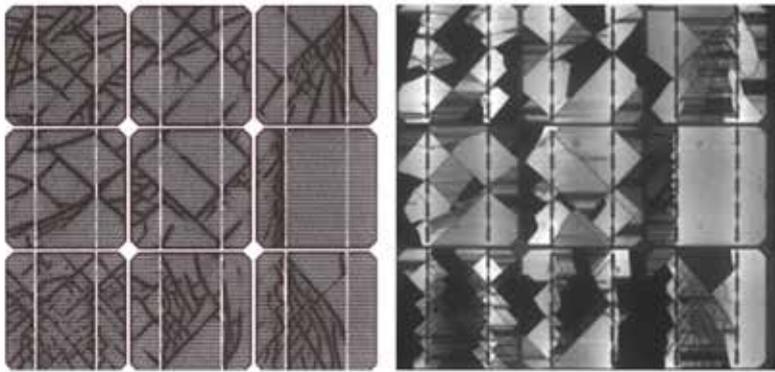
Figure 6. Section from a PV module (nine cells): photograph with excessive contrast (left) and electroluminescence image (right)

An extreme example is shown in Figure 6. A section of a PV module is shown which is significantly affected from “snail trails”. The comparison between photograph and electroluminescence image confirms that each dark trace is correlated to a cell

crack. In this case however, so many cracks have formed that many cell areas became electrically isolated and hence, were lost for the module’s performance. In this case, one can even compare it quantitatively: the measured reduction in power output was ~40% which matches almost exactly the sum of inactive cell area.

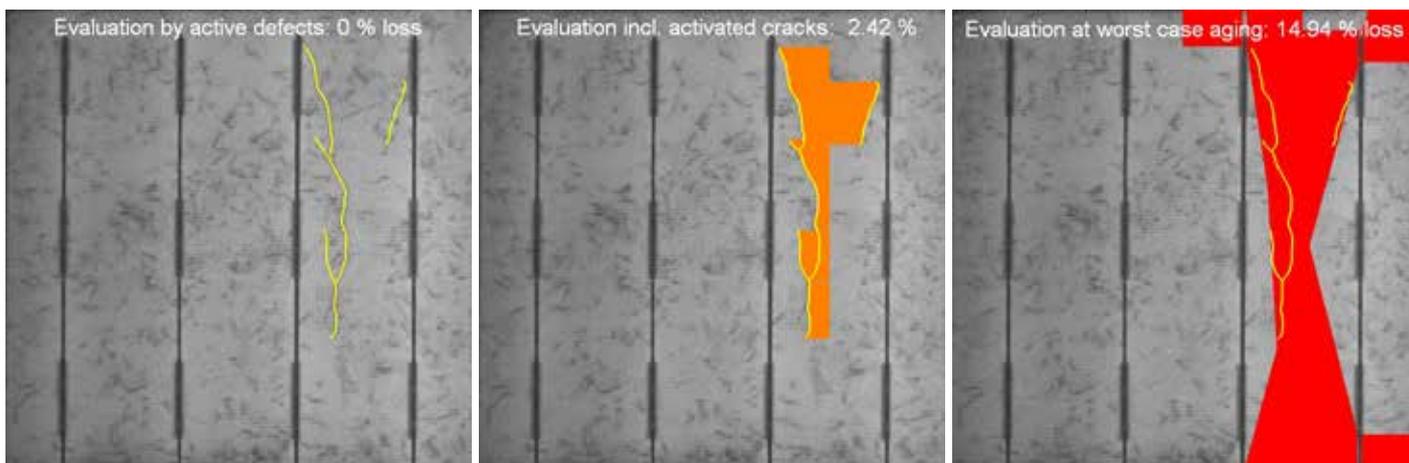
Figure 7. Automated identification of cracks can serve as a basis for the quantitative estimation of expected power losses. Left: crack detection using image processing algorithm. Middle: estimation of inactive cell area due to cell crack. Right: quantification of worst case scenario due to detected crack

image processing algorithms, it is not only possible to detect the smallest cracks reliably; the prospective power loss can also be predicted by software simulation, assuming that the inactive cracks become active later on in the field (see Figure 7). An automatic EL inspection in module production right before lamination enables the replacement of defective cells and avoids both “snail trails” and, even worse, cracks which will cause power loss in the module.
