Inspection of PV plants using drone-mounted thermography

Plant inspection | Infrared cameras mounted on drones offer a means of detecting instances of equipment malfunction in PV power plants. Claudia Buerhop-Lutz explains some of the faults such an approach can help reveal

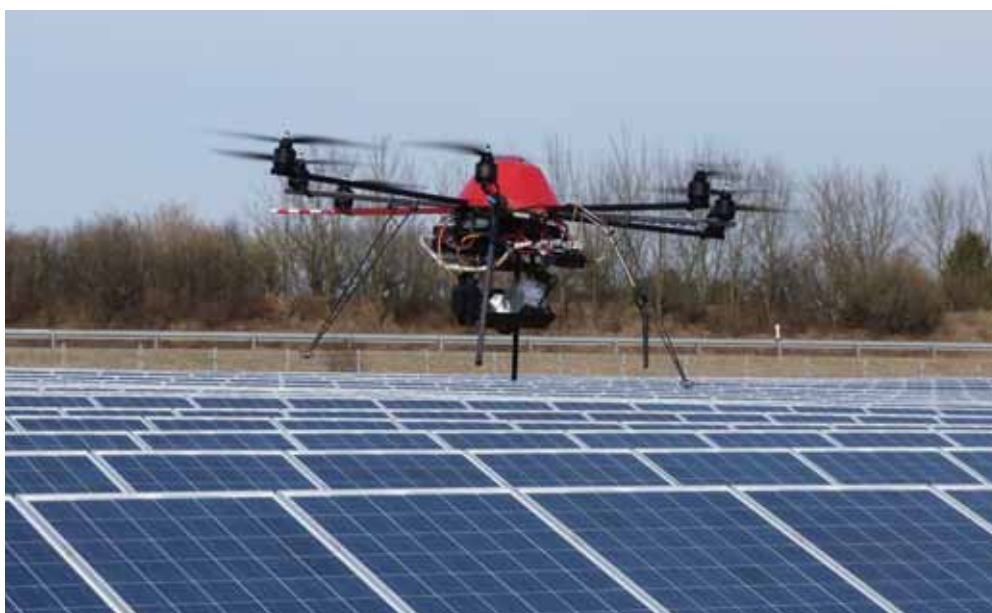
Figure 2: Aerial IR image of an extended solar park, approximately 4MWp, ambient temperature = 15°C , solar irradiance = 420W/m^2 , showing two irregularly heated module strings that indicates electric disconnection of these strings.

Figure 2 shows a typical IR overview of a PV plant. Temperature gradients across a larger area of the PV plant due to inhomogeneous irradiation or locally differing heat transfer become visible. These phenomena have to be carefully distinguished from optical effects. Singular spots, cells, substrings or module strings with elevated temperatures are a strong indication of faults. This temperature rise is linked on the one hand with heat generation on the other hand with electric losses.

Nevertheless, the solar park of Figure 2 has two irregularly heated, outstanding module strings, marked in the IR image. Presumably, these two module strings are not electrically connected to the inverter. In this case the absorbed solar energy is only converted to heat. For this reason these strings have a higher temperature than their neighbouring modules and are visible in the IR image. Typical temperature differences are 4 to 6K. The most reasonable explanation is that this module string is not connected to the converter or the electric connection is lost. The electric power output is zero. The consequence is a significant power loss.

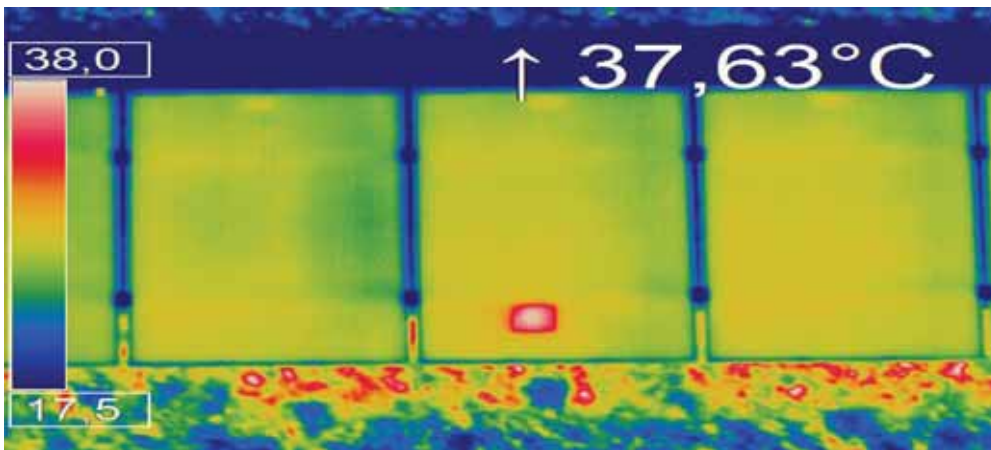
Figure 3: IR images (close-ups) of two typical module defects.

▲ **Cell defect with homogeneously elevated cell temperature.** Temperature = 37.6°C, temperature of good neighbouring cells = 27.5°C, ambient temperature = 14°C, solar irradiance = 410 W/m².

be manifold: manufacturing, transport, installation damage as well as natural lifetime degradation. Fractured cells in PV modules are visible in IR images (see Figure 3, upper image). The temperature difference to the neighbour cells can be high depending on the fracture characteristics, the operating point and the measurement conditions. (For example, we found sample module with $\Delta T > 100K$ for distinct cells.) Normally, just the cell with the largest cell fracture shows the temperature increase. Therefore, the resulting module power is determined by the failure characteristics.

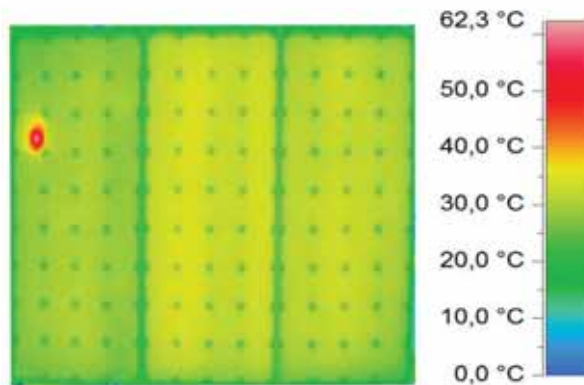
► **Point defect (defective solder joint) with locally raised temperature.** T = 62.3°C, temperature of good neighbouring cells = 29.3°C, ambient temperature = 9.3°C, solar irradiance = 760 W/m².

Faulty soldering is another frequent failure. Typically, the temperature rises locally at the sites of open or bad solder joints (see Figure 3, lower image). The area is much smaller than the area of a cell and therefore called hotspot. The spot can be at fairly high temperatures. A temperature difference of $\Delta T > 33K$ is measured for the example in Figure 3. At higher irradiance on a summer day even higher local temperatures may be reached. This can harm the module, accelerate ageing and reduce the power output because of material degradation. The number of such defects visible depends on the amount of bad solder joints. The impact of defective solder joints on the power output is determined by the number of defects and
