# Properties of encapsulation materials and their relevance for quality control and recent field failures

**Module defects** | The properties of module encapsulant materials are coming under closer scrutiny as their role in a number of common field failures becomes better understood. Juliane Berghold and Tsuyoshi Shioda report on new testing methods being developed to analyse the composition of encapsulants and improve the quality control of this crucial material

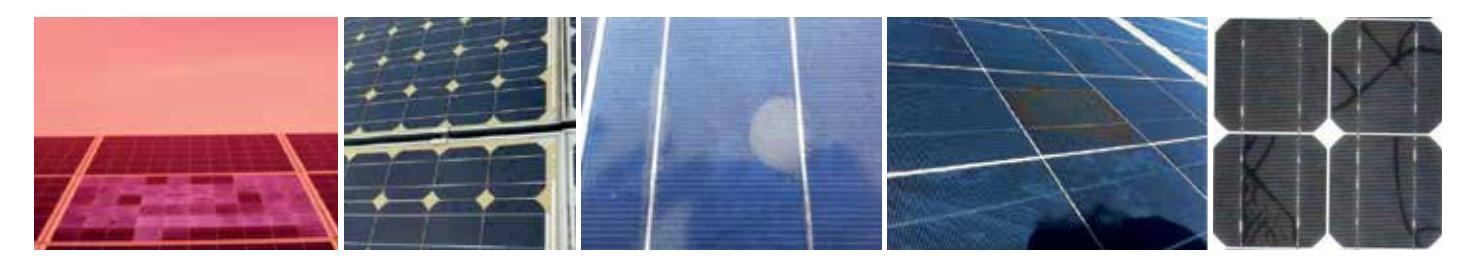
n increasing number of frequent and energy yield-relevant field failures are not covered by IEC testing. In this context the properties of the encapsulation material are coming increasingly into the focus due to their impact on the long-term stability of solar modules in the field. Furthermore, in the future the majority of PV installations worldwide will be exposed to more stressful conditions, since the market share of installed PV in desert-like and tropical surroundings will further increase in the coming years. Accordingly, the long-term stability of the encapsulation material will become crucial. For instance electrical and chemical properties of the encapsulation material have been shown to play an important role for the occurrence and avoidance of various module field failures, such as potentialinduced degradation(PID), 'browning', delamination, corrosion and 'snail trails' (from left to right in Figure 1).

Figure 1. Different module field failures with indirect or direct influence of encapsulation material environmental conditions the PV module is exposed to (such as temperature and humidity). As a result the specific 'failure pattern' for PID that is observed in a PV plant can be very different as illustrated in Figure 3.

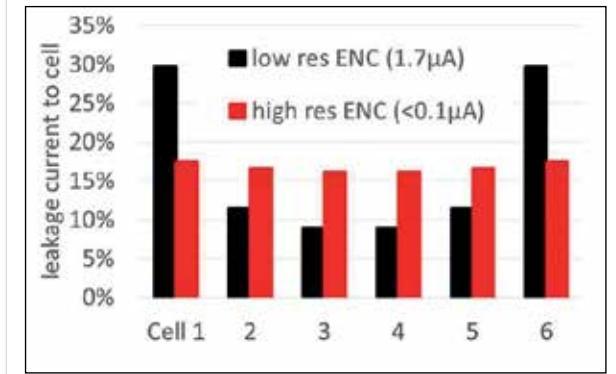
As 'media' for charge carrying and mass transportation within the PV module the electrical properties of the selected EVA material determine the level and distribution of leakage current. The leakage current and the resulting ion transport in a PV module is very relevant for field failures such as PID. In Figure 2 the leakage current distribution is shown for two different EVA materials – with very high and very low volume resistivity.

Figure 2. Leakage current distribution depending on kind of encapsulation material (high volume resistivity (10 <sup>15</sup>  $\Omega$ cm) versus low volume resistivity (10 <sup>13</sup>  $\Omega$ cm)) [1]

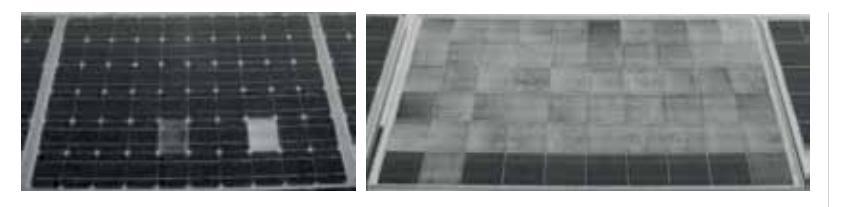
Figure 3: electroluminescence images from PID-affected modules in field: 'surface' PID (left) and 'frame' PID (right) depending on different leakage current distribution in PV modules [1]

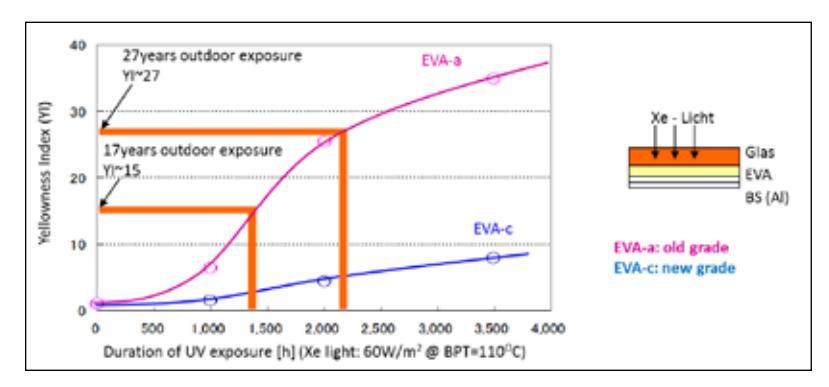
An example of the impact of different EVA formulations on the trend for yellowing/browning is given in Figure 4. The difference for the yellowing index is highlighted for 17 and 27 years of outdoor exposure for a location in Japan. However, the difference for these two EVA formulations would be even more

Figure 4. Different trends for the yellowness index for two different EVA formulations

pronounced for locations with very high irradiance, such as Chile.

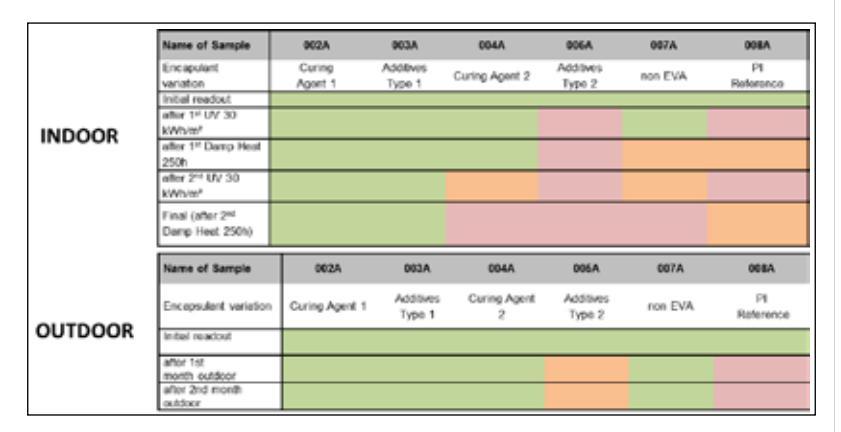
Figure 5. Snail trail formation in indoor experiment and outdoor exposure depending on chemical agents and additives in the EVA (red: clear snail trails; orange: light snail trails) [2]

Another example of the direct impact of the encapsulant is the frequently observed so-called snail trail formation on PV modules in solar plants. Snail trail formation was investigated for its dependence on the specific EVA formulation, including specific chemical agents and additives. The results of indoor and outdoor experiments (Figure 5) revealed that the formation of snail trails was dependent on the presence of certain additives in the EVA material.

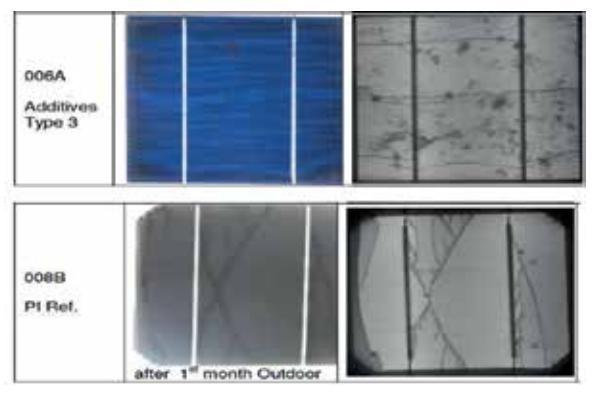
Figure 6. Different visual appearance of snail trails depending on additives in EVA [2]

Also the visual appearance of the snail trails was found to be different depending on the specific additives involved (Figure 6).

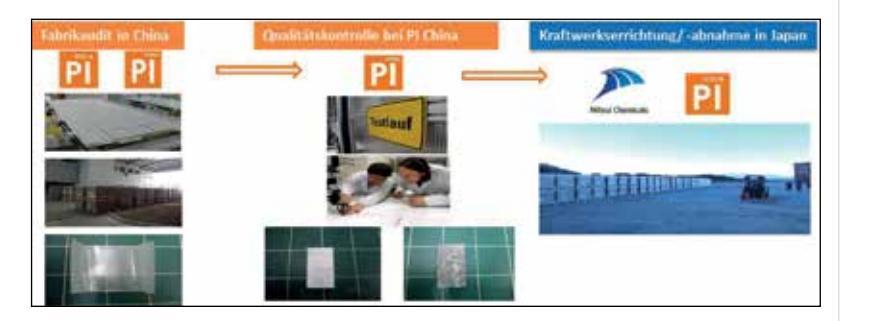
Figure 7. EVA sampling for finger print test during quality control for PV plant

For the verification that the modules shipped to the site in Japan were manufactured with the same materials, EVA samples were taken from the PV modules during the QC sampling test in China and finger print testing was conducted with the fresh EVA sample from production and the cured EVA sample taken from the modules designated for shipment to Japan (Fig ure 7).

In this case the finger print test revealed the nonconformity of the two samples. For selected additives the concentration of selected additives were drastically different - for the reference material from production compared with the EVA material utilised for the production of the PV modules for the solar project in Japan.
