# Detecting cell cracks and other PV module failures with UV fluorescence

**F**inding damaged modules impairing the PV system performance: a cost-intensive issue

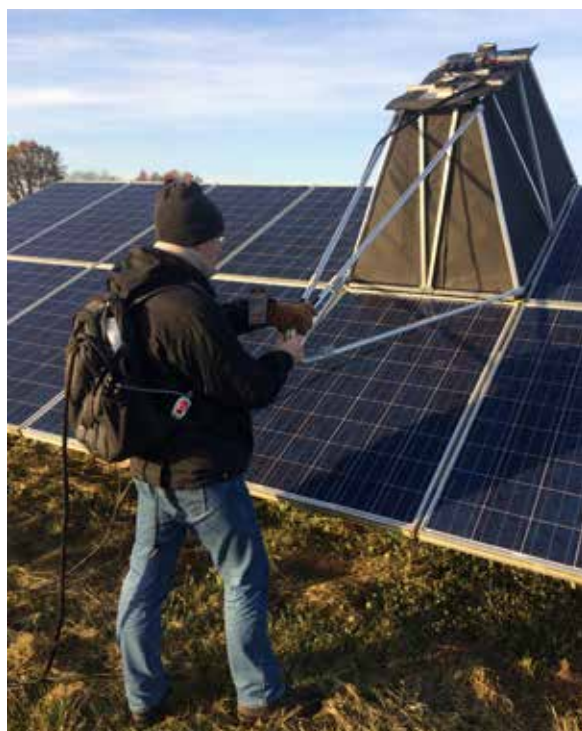
cells and an estimation of the criticality of them. Furthermore, EL reveals interrupted cell interconnection ribbons, short circuits and cell shunts. The infrared thermography reveals temperature inhomogeneity and allows for the detection of hotspots caused by shunts as well as cracked cells or short-circuited bypass diodes [4]. This technique is easier to implement than EL as it does neither require the disconnection of the modules from the rest of the PV system, nor their electrification with an external power source. Nevertheless, the modules need to be in operation under a sufficient solar irradiation ( $>600 \text{ w}/\mu^2$ ) in order to induce detectable thermal features.

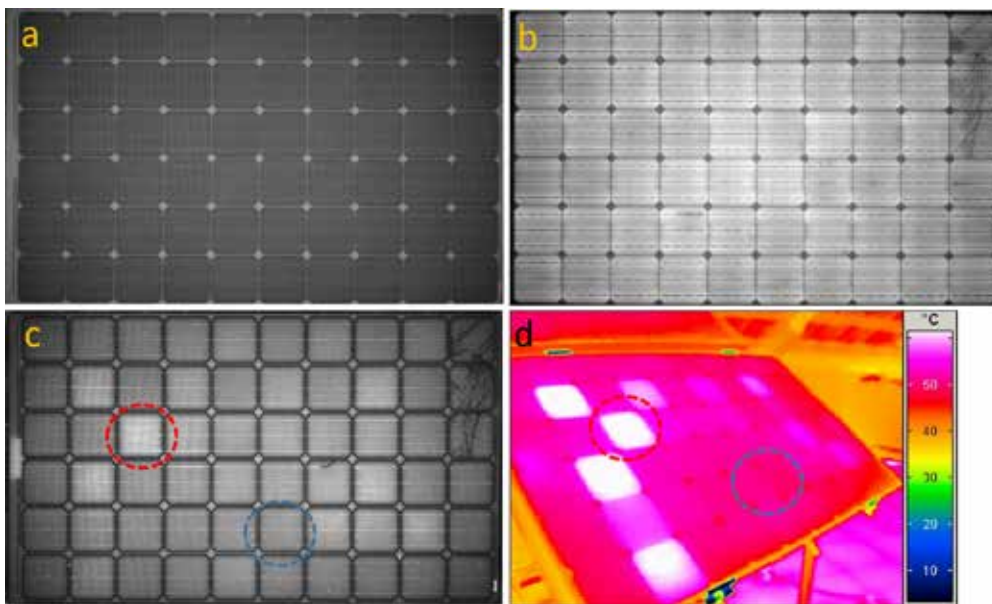
**Figure 2. Fluorescence (a) and electroluminescence (b) images of a transport-damaged new PV module before sun exposure. Fluorescence image (c) of the module after 70 days of sun exposure in short-circuit and infrared thermography image (d) of the module under an irradiance of 780W/m<sup>2</sup> [9]**

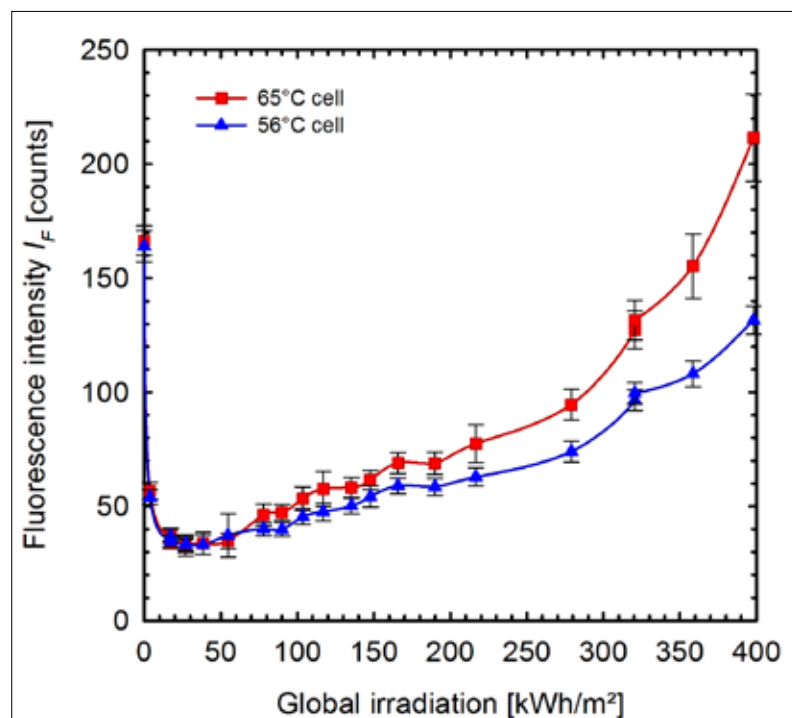
**Figure 3. Fluorescence intensity over time measured on two solar cells with different operating temperatures. The lines are guides for the eye**

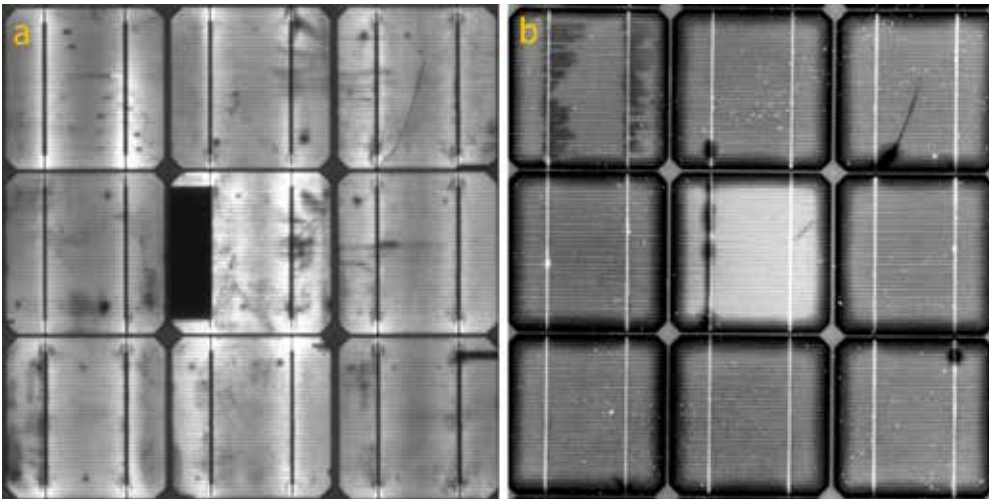
**Figure 4. Electroluminescence (left) and UV-fluorescence (right) images of a PV module area showing a cell in which a quarter has been electrically isolated by a crack and which subsequently reaches a higher temperature in operation**

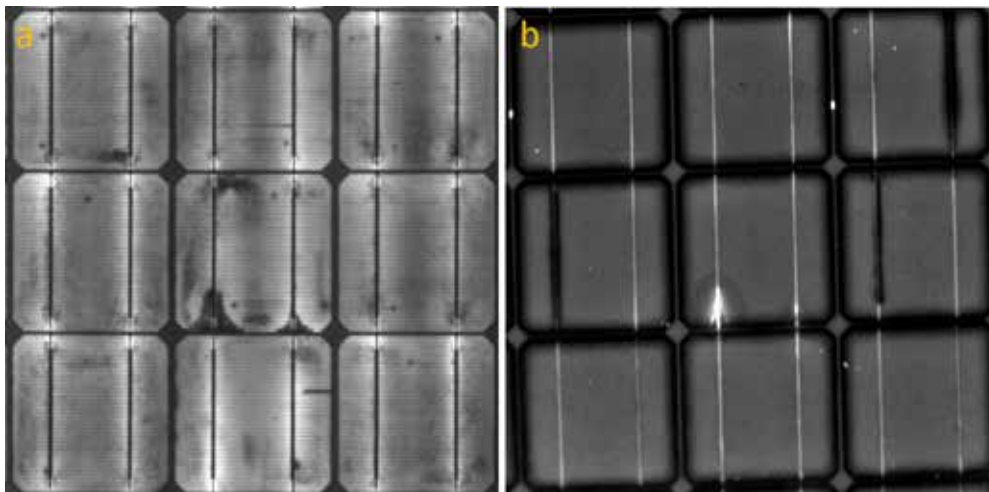
**Figure 5. Electroluminescence (left) and UV-fluorescence (right) images of a PV module area with a cell showing damages correlated with a local overheating**

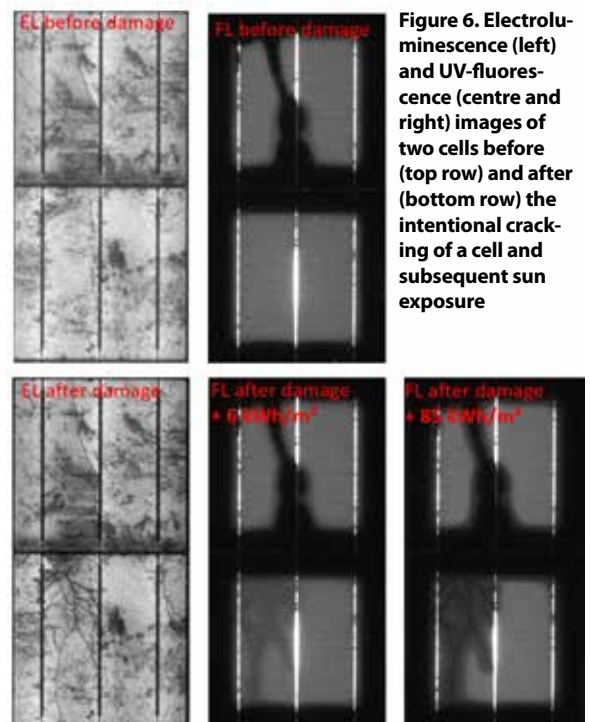
**Figure 6. Electroluminescence (left) and UV-fluorescence (centre and right) images of two cells before (top row) and after (bottom row) the intentional cracking of a cell and subsequent sun exposure**

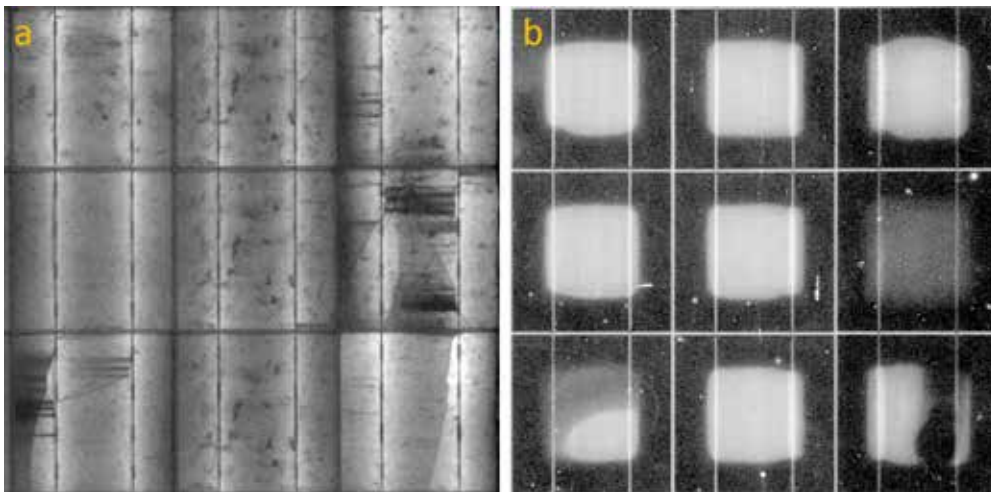
**Figure 7. Electroluminescence (left) and UV-fluorescence (right) of a PV module eight weeks after a hailstorm and showing recent and older cracks**
