# Cell-to-module losses in standard crystalline PV modules – An industrial approach

Eduardo Forniés, Aurinka PV Group SL, Madrid, & José Pedro Silva, CIEMAT – División de Energías Renovables, Madrid, Spain

## ABSTRACT

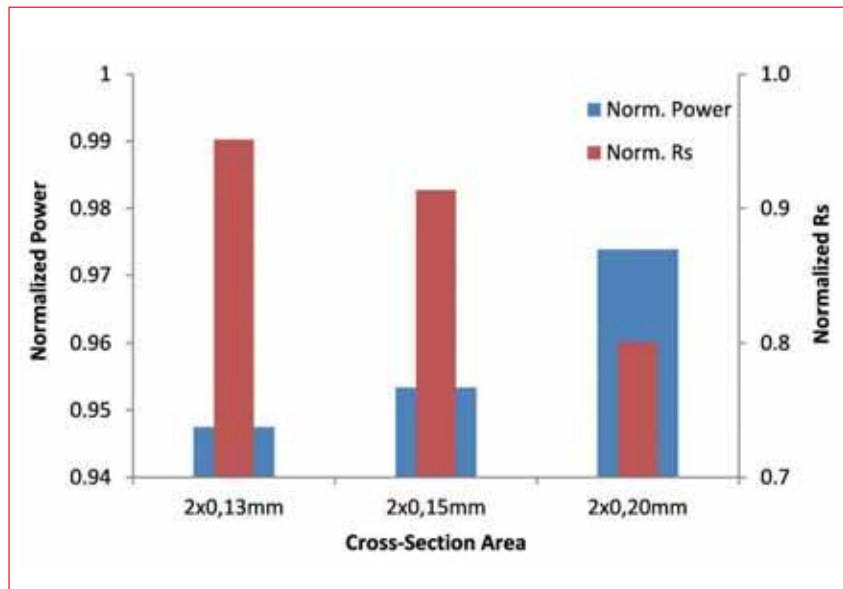
Figure 1. Module power and series resistance vs. tabbing ribbon thickness.

To clarify the influence of tabbing ribbon thickness on power output, 82 modules were manufactured with the

same materials and solar cells. Multicrystalline solar cells of dimension 156mm × 156mm and two busbars were assembled in a 10 × 6 configuration; the solar cell efficiency was the same for all the modules. Three different tabbing ribbon thicknesses were used in the experiment. Fig. 1 shows the average power and  $R_s$  of the modules: the average power has been normalized to the sum of the nominal power of 60 cells, and  $R_s$  has been normalized to the maximum  $R_s$ . An increase in module power inversely proportional to the series resistance was obtained experimentally.

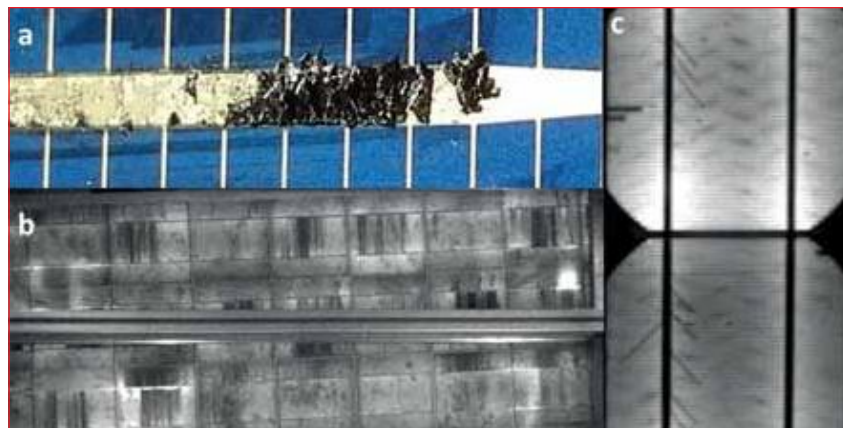
Figure 2. Effects of crystal damage: (a) view of the solar cells affected by crystal damage after the peeling test; (b) EL image of a module with several cells affected by crystal damage; (c) V-shape breakage patterns of single-crystal solar cells, caused by shear stress after the soldering process.

The thickness of tabbing ribbon nevertheless has a direct influence on the silicon just below the bus: because of the different thermal expansion coefficients (TECs) of copper and silicon, breakages occur during the soldering process, leading to what is called *crystal damage*, as shown in Fig. 2(a). This defect can result in a serious lack of contact, which is exacerbated during thermal cycling once the module has been installed. If the crystal damage is extensive, it can easily be detected by electroluminescence (EL) imaging (Fig. 2(b)), and the module rejected; however, if the defect does not extend very far, the module may pass the quality controls and then be installed. In this situation, under outdoor thermal cycling, the module may be subjected to a high power loss due to the propagation of the defect. To counteract this effect the yield strength of the tabbing ribbon has been reduced from 90N/m to 30N/m, reducing the crystal damage, also known as *rip-out*.

It has been observed that multicrystalline silicon solar cells are more susceptible to this defect, while single-crystal solar cells, under high shear stress, tend to break in a V-shape fracture, as seen in Fig. 2(c).

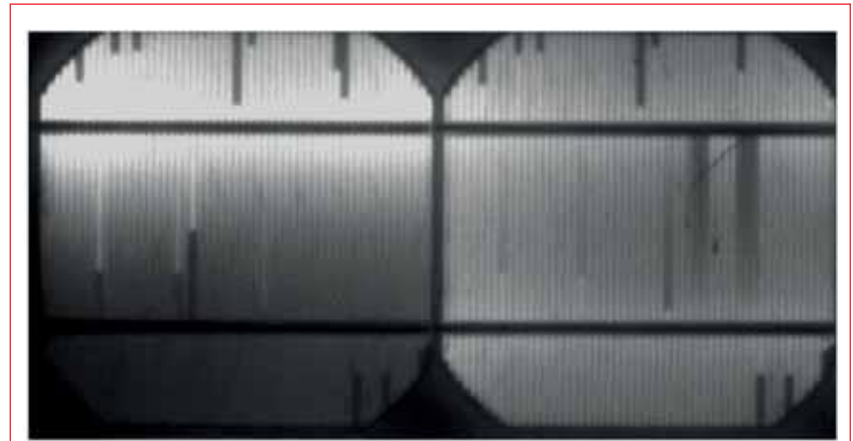
Figure 3. EL image of a module affected by an unsoldered tabbing ribbon – the cell affected is on the left side. The lower busbar is unsoldered and shows up as a dark busbar, whereas the upper busbar, which is forced to transport all the module current, appears brighter.

The flux is also a direct agent, which plays an important role during soldering. An eventual clogging of the flux dispensers leaves the cell buses without flux just before soldering. This gives rise to unsoldered cells in the module, which translates to a loss of power (Fig. 3). In this case, the current generated by the module is forced to pass through the soldered buses, which leads to a brighter appearance under EL testing (upper busbar in Fig. 3).

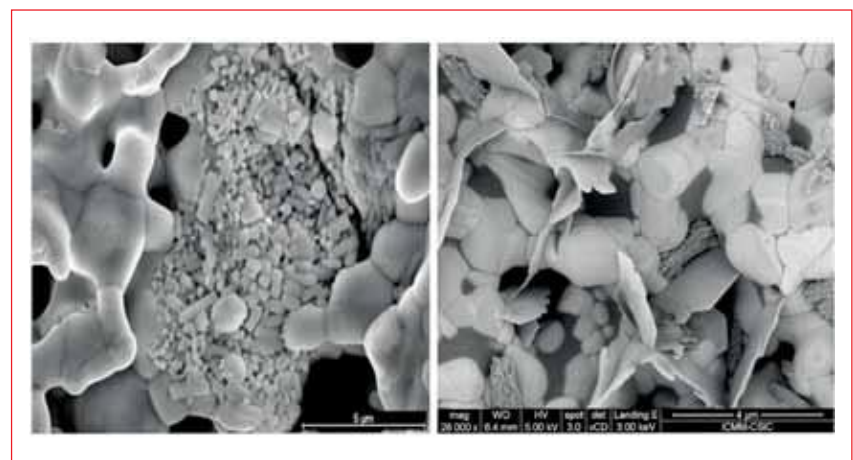
Figure 4. Scanning electron microscope (SEM) images of front busbars that presented adherence failure in the peel test. Formations different from those of a silver microstructure can be observed.

In the case of problems arising from solar cell manufacturing, contaminants in silver paste have a strong influence. A poor-quality silver paste, in which elements different from those related to glass frit formation or conductivity purposes are present, may have a negative effect upon the adherence strength of both cell and tabbing ribbon. In Fig. 4, different solar cells originating from failing lots in the soldering process were analysed. Several microstructures were detected, of which the main components were metal oxides. The soldering failures derived from those structures were not only adhesive but also cohesive.

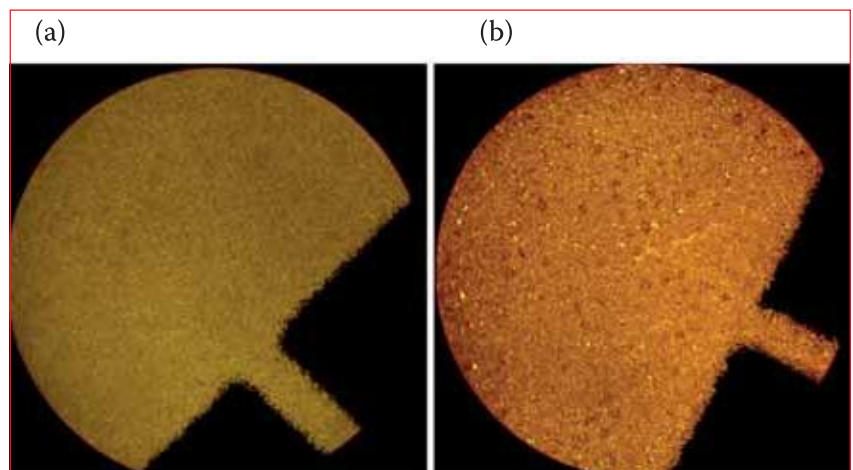
Figure 5. (a) Optical microscope image of a normal front busbar. (b) A front busbar affected by bright spots.

same manufacturer and the same lot; some of these were found to have the bright spots (Fig. 5(b)). During solar simulator testing, modules with affected

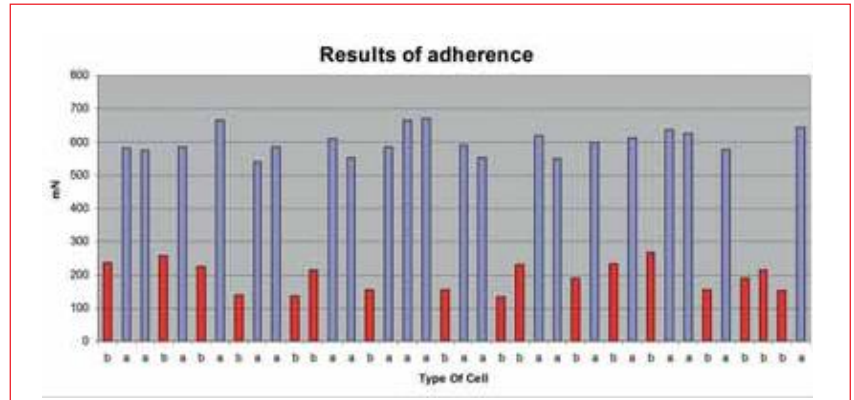
Figure 6. Red columns: adherence test carried out on cells affected by bright spots (see Fig. 5(b)). Blue columns: adherence test results for cells without bright spots (see Fig. 5(a)) from the same lot.

After automatic soldering, an adherence test was carried out. The

results, presented in Fig. 6, reveal the poor adhesion of cells with bright spots in comparison with those not affected by this issue.

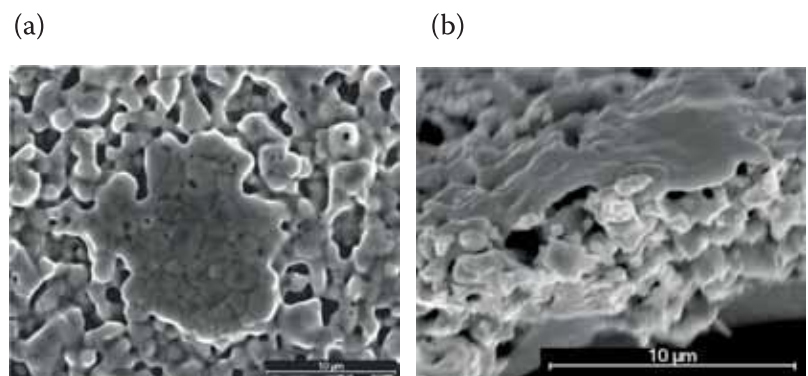
Figure 7. (a) Surface SEM picture of the microstructure of one 'bright spot'. (b) Tilted SEM picture of a busbar cut through a bright spot.

For a more detailed explanation of the problem, the cells were inspected using a scanning electron microscope (SEM). The flake-shaped grains that have formed on top of the busbar have a softer surface than the silver paste surrounding them (Fig. 7); this makes the reflection of light more intense, resulting in the appearance of bright spots. An energy dispersive X-ray (EDX) analysis revealed that those grains are surface structures formed by pure silver (Ag), whereas the area surrounding them is mainly formed by silver as well as other metals and oxygen. The adherence of the tabbing ribbon onto the silver busbars depends on the number of flakes per mm<sup>2</sup>. Because of the flat area of the flakes, there is a detrimental effect on adherence.

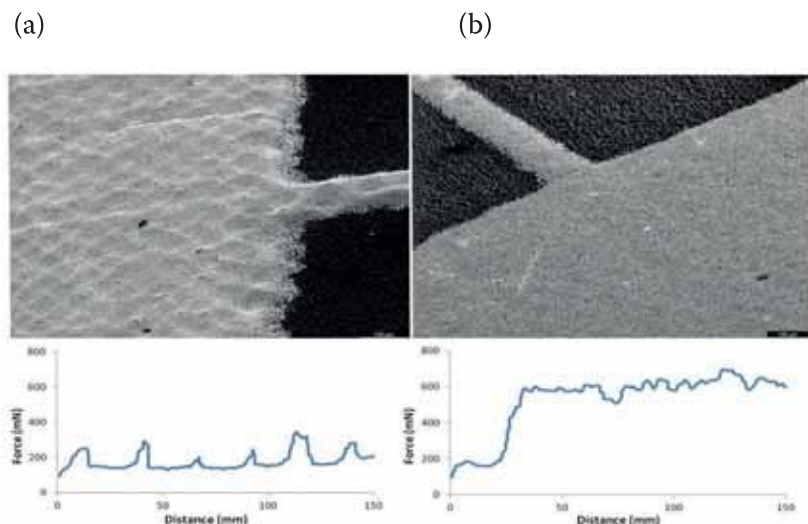
Figure 8. (a) SEM image of a front busbar with the topography derived from the mesh of the screen-printing process (top), and the corresponding adherence test result for one of the soldered buses (bottom). (b) SEM image where the mesh topography is absent (top), and the corresponding adherence test result for one of the soldered buses (bottom).

Regarding silver paste viscosity, a correlation between the macroscopic topography of the busbar and the adhesion has also been detected. The topography of fired silver paste is determined by paste properties (viscosity, emulsion thickness, etc.) and screen dimensions (i.e. wire diameter of the mess). During in-line quality control of the soldering process (peel test), an adhesion failure was detected in a certain lot of cells from the same supplier (Fig. 8, bottom left). The topography of a group of cells, with good and bad results during the peel test, was analysed by

SEM: the difference between them shows up very clearly (Fig. 8, top). A distinct topography with a mesh-shaped pattern (arising from the mesh of the screen-printing process) is present in those cells that suffered adhesion failure, while the busbar surface of 'good' cells appears to be flat and soft. Several modules were manufactured using solar cells that demonstrated the above-mentioned busbar patterned topography and using solar cells with a soft busbar surface. The materials used and the soldering conditions were the same. The modules affected by the pattern issue produced 2% less power than those made using 'normal' cells.

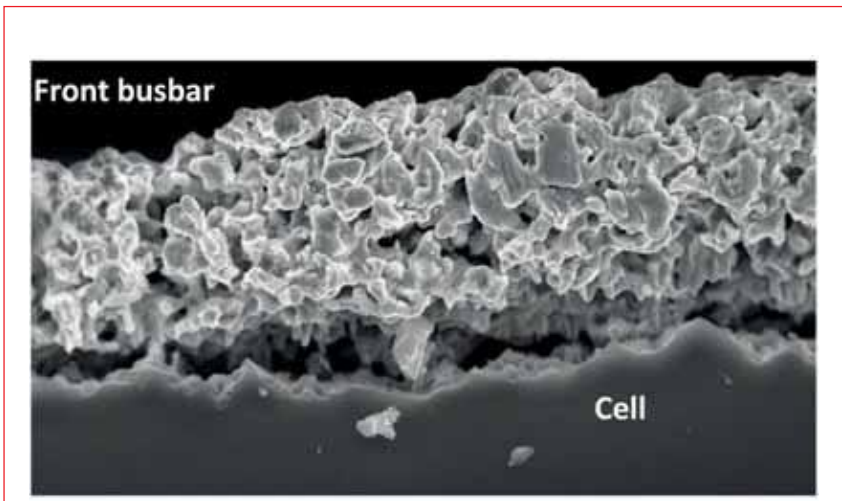
**Figure 9. Front busbar of a cell affected by a bad contact: total delamination is observed.**

these result in deficient contact between cell and silver paste, and can even lead to busbar flaking, as shown in Fig. 9.

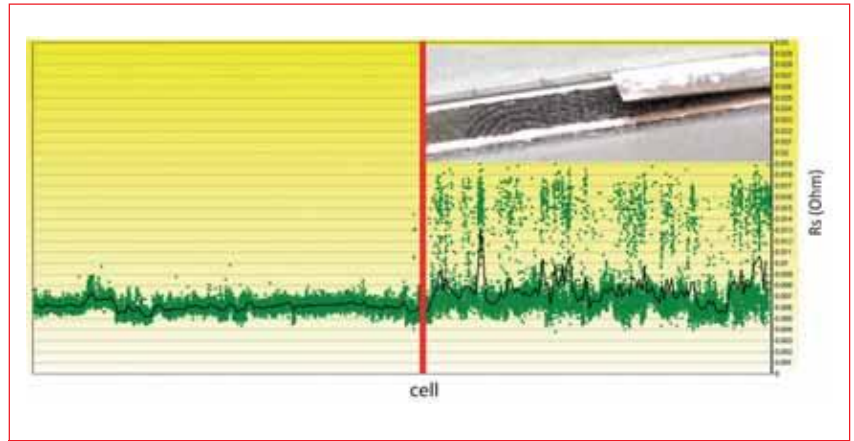
Figure 11. Series resistances of the cells suffering from the black bus effect (right) compared with cells without this failure from the same supplier and with the same efficiency (left).

The lot of cells that exhibited this problem was electrically measured and compared with another lot from the same supplier having the same efficiency (Fig. 11). As can be deduced from the graph, the lot afflicted by

the 'black bus' effect presents a very high scattering of  $R_s$  in its cells, with  $R_s$  values of up to 20mΩ, well above the standard 4–8mΩ. The inset in Fig. 11 shows, as final evidence of the existence of a contamination interlayer, a fingerprint on one of the affected cells after the peel test.

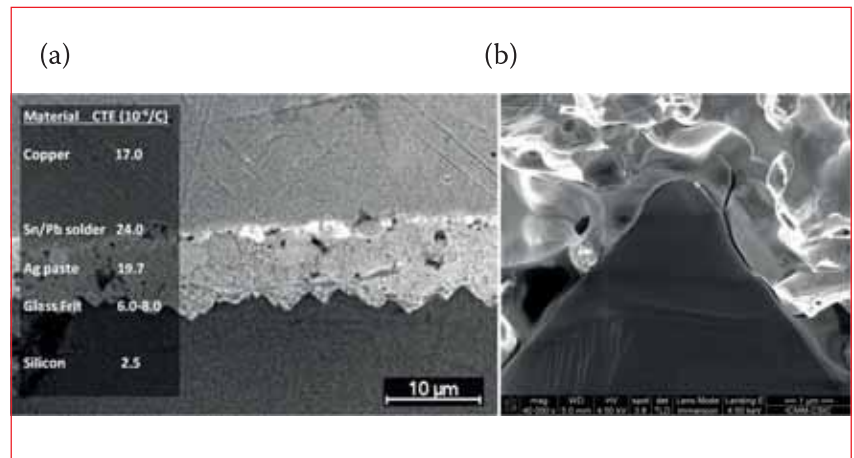
Figure 12. (a) SEM section view of one soldered solar cell: tabbing ribbon, front busbar and silicon are shown, and the CTEs are specified in the inset. (b) SEM section view of a fracture in the glass of a solar cell.

With regard to the nature of all the interfaces involved in solar cell interconnection, it is important to take into account the difference between the coefficients of thermal expansion (CTEs) of the different interfaces that participate in the soldering. Fig. 12(a) is an SEM photograph of a section view of a soldered solar cell. In this image all the interfaces are displayed and the CTE of each material is also indicated (CTEs were extracted from Moyer et al. [18]). From Fig. 12 it can be inferred that the solder strongly smears throughout the interface area because the thickness of the solder decreases from 15–20 microns down to a few microns. It is likely that a combination of temperature and the pressure of the tabber–stringer pins on the tabbing ribbon cause the thinning of the solder. An EDX analysis of the interface compositions confirms the composition shown in the inset of Fig. 12(a).

As reported by Moyer et al. [18], the largest change in CTEs takes place at the silicon–glass and glass–Ag interfaces, which means that, during thermal processes, the residual stress is concentrated mainly at those interfaces. As a consequence of silver paste components and the parameters of the firing process, a thick glass interface may be formed. When the solar cell is subjected to the thermal stress of the soldering process, the resulting shear stress can cause the glass to fracture. As a result, an adhesive failure of the silver busbar and the solar cell occurs and the known black bus effect may appear. Fig. 12(b) shows a fracture in the glass of a single-crystal solar cell after soldering.

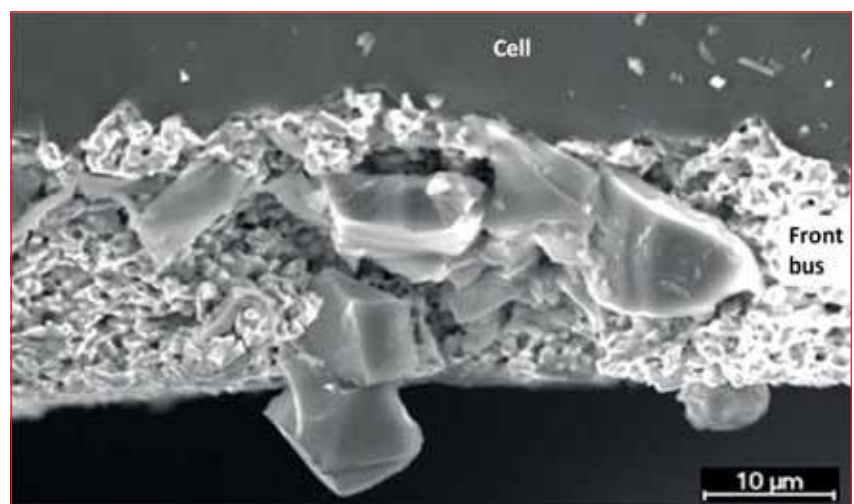
Figure 13. Example of bulk contamination of a front busbar.

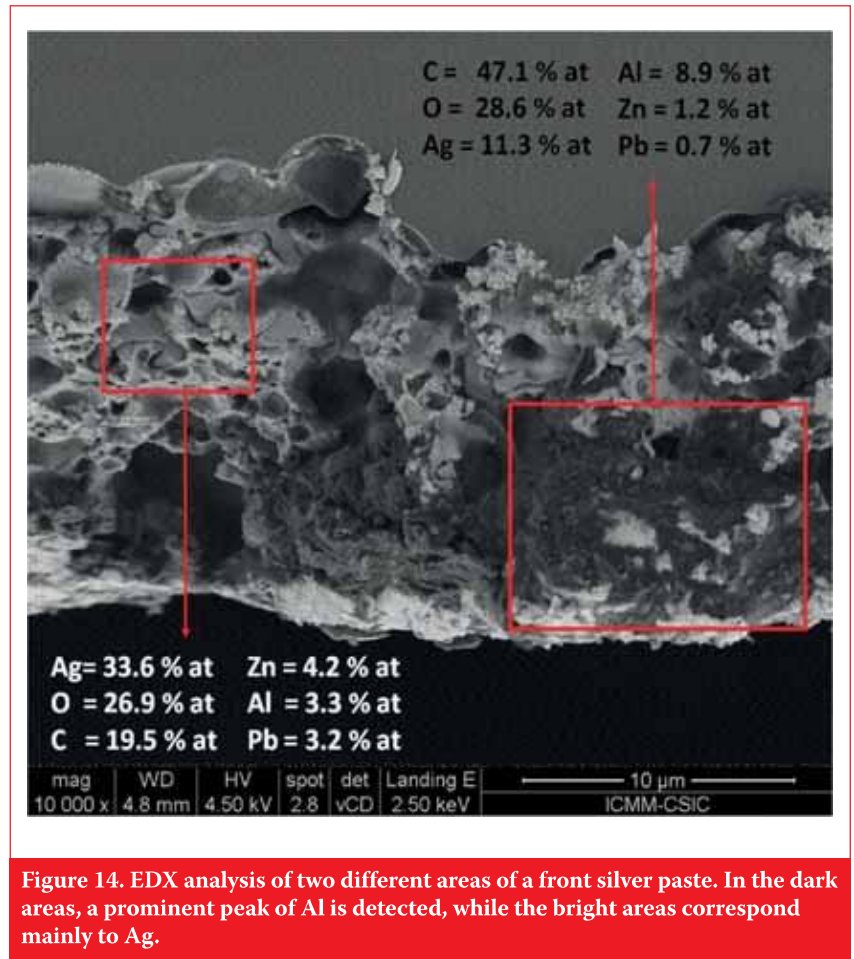
Figure 14. EDX analysis of two different areas of a front silver paste. In the dark areas, a prominent peak of Al is detected, while the bright areas correspond mainly to Ag.

In another sample investigation that took place in an industrial environment, a massive cohesive failure was observed in solar cells where the front busbars presented high concentrations of C and O, as well as Al as a contaminant; the latter is extremely rare and potentially harmful as a possible origin of shunt formations due to Al spiking. As usual, after the peel-test failure the cells were inspected in the laboratory. An SEM and EDX analysis was carried out on the solar cells, and Al was found in the bulk of the silver paste (Fig. 14).

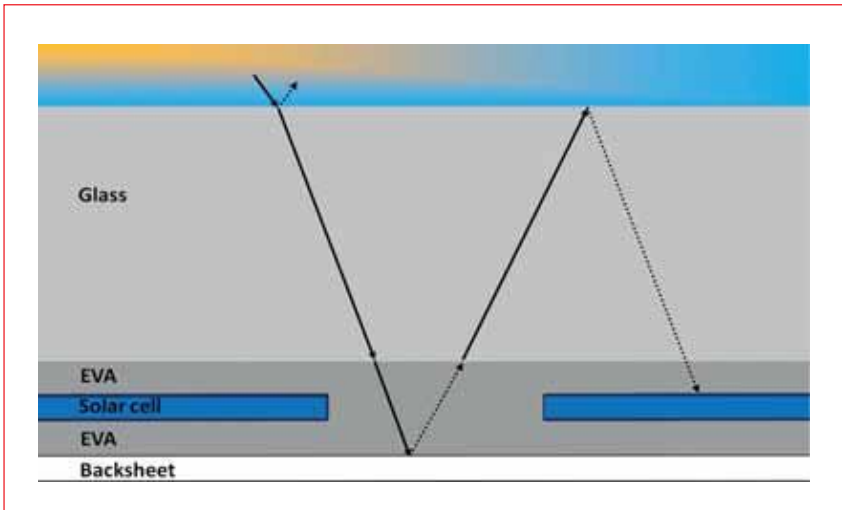
**Figure 15. Sketch of the optical path related to backsheet reflections into the module.**

Other gains are mainly derived from reflections on the tabbing ribbon and on the exposed backsheet where the cells are not present (i.e. cell spacing areas – see Fig. 15). The light reflected is directed to the glass–air interface and partially reflected back onto the cells.
