Cavities observed in PV modules, induced by the tabbing and stringing process

Eric Pilat¹, Manuel Hidalgo², Dominique Thil² & Marion Vite¹

¹CEA-INES, LMPV (Module Laboratory), Le Bourget du Lac; ²ARKEMA Sollia Laboratory, LMPV, Le Bourget du Lac, France

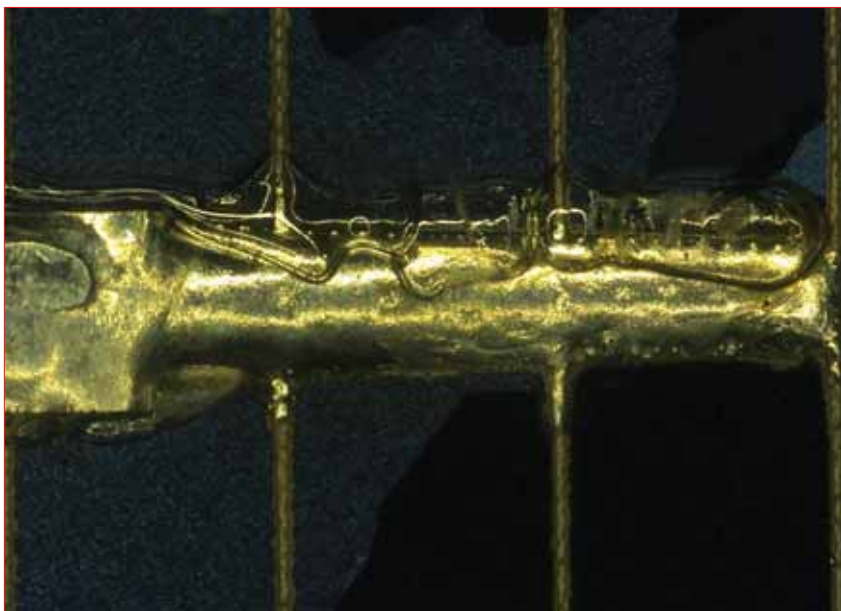
Figure 3. Defect observed using 100× magnification.

Spots may be large enough to be seen by the naked eye, as in the photo in Fig. 2, but more often than not one has to look carefully with an optical microscope (Fig. 3) in order to detect them (100× magnification is more than enough).

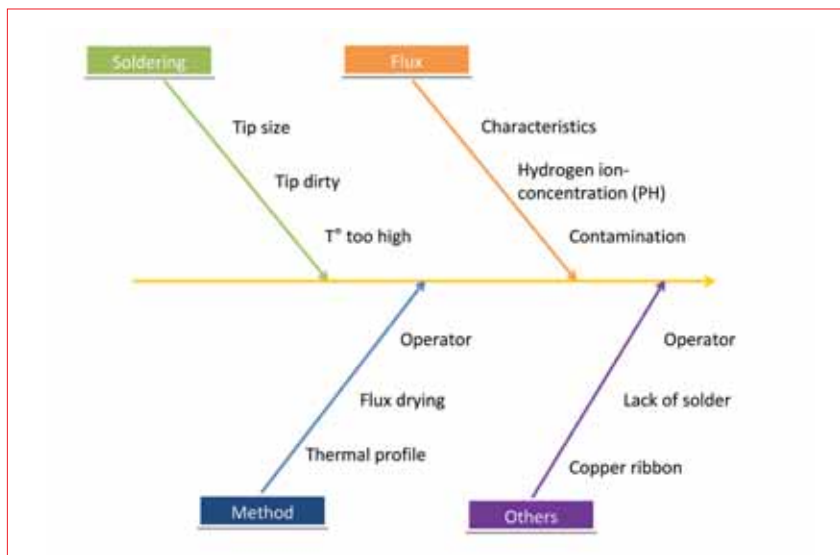
Figure 8. Fault tree analysis.

Taking into account these experimental results, an FMECA approach (failure modes, effects and criticality analysis) was followed. In the fault tree analysis, four families were identified (Fig. 8). From this analysis, and the previous results with the thermoplastic encapsulant, it became clear that the soldering step could be a major contributor to the presence of defects.
