Fluorescence imaging: a powerful tool for the investigation of polymer degradation in PV modules

Jan Schlothauer, Sebastian Jungwirth & Beate Röder, Humboldt-Universität zu Berlin, Berlin, Germany, & Michael Köhl, Fraunhofer Institute for Solar Energy Systems (ISE), Freiburg, Germany

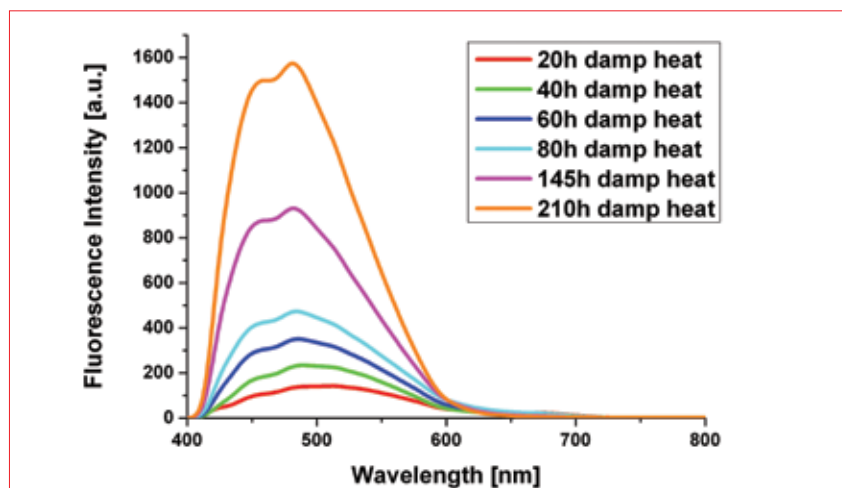
Figure 1. Fluorescence spectra of a damp heat-aged mini module at early ageing states.

The spectra of the mini module shown in Fig. 1 display the general behaviours of the measured fluorescence. The fluorescence intensity grows monotonically with increasing ageing time. It is clear from the image that signals are visible after times of only about 20 hours of accelerated ageing. The high sensitivity of the setup would even allow earlier fluorescence detection. A continuous growth of the signal was observed during test periods up to 2,000 hours (see Fig. 2), a common duration for service life tests. Fluorescence was detectable on any polymer encapsulant of the modules investigated so far. The results show the applicability of fluorescence detection as a method of assessment of the degradation of the polymer in a PV module [7,8].

Figs. 1 and 2 show the ageing time-dependent fluorescence signal without spatial variation. Conducting measurements with spatial resolution on complete PV modules allows for the display of fluorescence intensity over the spatial coordinate, as shown in Fig. 4. Plateaus of high fluorescence intensity separated by trenches of low fluorescence intensity can be clearly distinguished. Spikes rising up from the plateaus spatially coincide with the position of the bus bars.

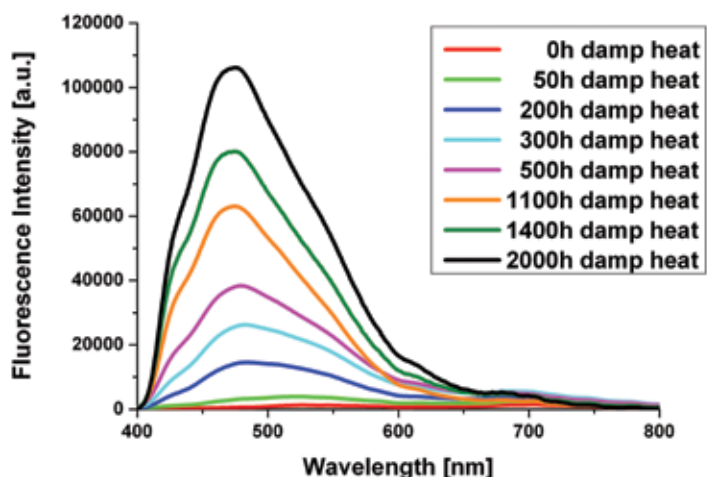
Figure 2. Fluorescence spectra of a damp heat-aged mini module during 2,000 hours of exposure time.

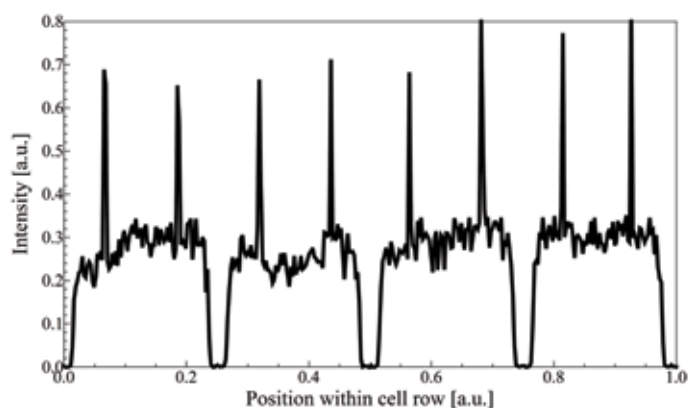
Figure 4. Total fluorescence intensity for scanning of a single line from module C1. The module was exposed at Zugspitze for two years. For anonymity reasons, a clipped section in arbitrary units is shown. The cells appear as plateaus of high intensity; the trenches of low fluorescence between them are actually wider than the spacing of the cells. The bus bars appear as high spikes.

Several processes can be said to cause this spiking effect: excitation UV irradiation might be reflected by the bus bars yielding a higher fluorescence; the fluorescence itself may be reflected, explaining the strong signal increase; or there may be a real difference in the local condition of the polymer due to the bus bars.

The trenches of low fluorescence between the plateaus are significantly wider than the spacing of the cells. A general assumption could be made that this behaviour is caused by a diffusion process. The degradation products which normally seem to be fluorescent are then chemically altered into non-fluorescent species.

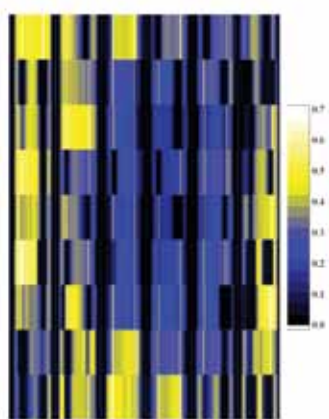
Figure 5. False colour image of the spatially resolved fluorescence intensity for module C2 (rows and/or lines were clipped for anonymity reasons). The module was exposed to Indonesia's tropical climate for two years. The intensity is normalized, showing lower fluorescence at the centre of the module.

Combining all scanned lines of a module and translating the intensity into colours yields a complete image of the module. Fig. 5 shows the results of two years of outdoor exposure in Indonesia, indicating the occurrence of fluorescence across the entire module with a significantly higher intensity near the edges. Higher fluorescence

intensity on the cells is associated with higher degradation of the polymer.

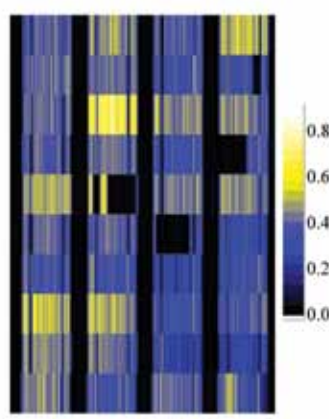
Figure 6. False colour image of the spatially resolved fluorescence intensity for module C3 (rows and/or lines were clipped for anonymity reasons). The module was exposed to a desert climate for two years. The intensity is normalized; peculiar spots appear on cells in lines 2 and 4 to 6 where the fluorescence on the cell disappears.

Fluorescence imaging was performed for numerous modules [11,12]. Another module was selected to demonstrate the ability of the fluorescence analysis to evaluate distinctive features. Fluorescence intensity suddenly drops to a very low level on certain cells. This effect can be seen for several cells on the C3 module in Fig. 6, though no visible changes were apparent. A line scan illustrates the difference between fluorescence intensities on the cell and the peculiar spot for cell number four in line two (Fig. 7).

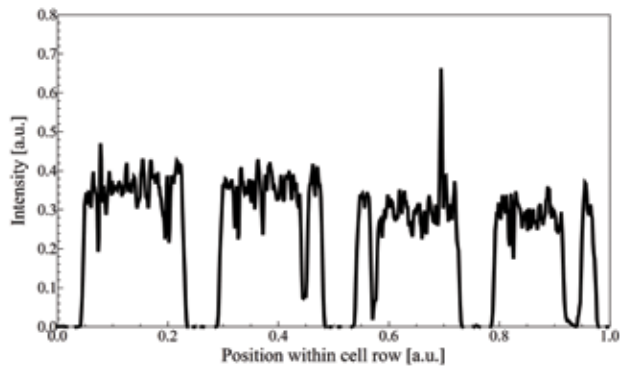
Figure 7. Total fluorescence intensity for scanning of line 2 of module C3. The spatial coordinate is the same as for the x-axis in Fig. 6. The cells appear as plateaus of high intensity; an additional trench of low fluorescence appears on cell number 4 (right-hand side).

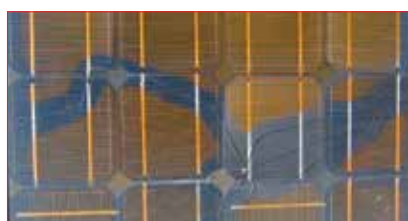
Figure 9. Photograph of a module after extended outdoor exposure at JRC (Italy) showing strong browning caused by photo degradation of the EVA and bleaching effects around the cracks in the cover glass. (This module is unrelated to other modules investigated in this project.)

Taking a closer look at Fig. 9, strong browning is visible on a module following outdoor exposure at the Joint Research Centre (JRC) in Italy for an extended period of time. The browning on the cells has reached a state which normally should not occur during the service life. The fact that the browning is visible to the naked eye indicates that the polymer is being tested at a very late stage. A bleaching of the colorant species occurs around the cracks in the cover glazing. It can be assumed that similar processes of diffusion through cracks in the wafer and in the glazing are the reasons behind the bleaching in the browning image (Fig. 9) and in the fluorescence image of Fig. 8.
