Inspection of PV plants using drone-mounted thermography

Plant inspection | Infrared cameras mounted on drones offer a means of detecting instances of equipment malfunction in PV power plants. Claudia Buerhop-Lutz explains some of the faults such an approach can help reveal

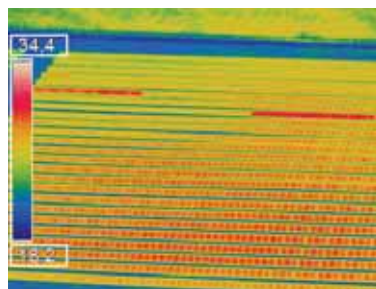
Figure 2: Aerial IR image of an extended solar park, approximately 4MWp, ambient temperature = 15°C , solar irradiance = 420W/m^2 , showing two irregularly heated module strings that indicates electric disconnection of these strings.

Figure 2 shows a typical IR overview of a PV plant. Temperature gradients across a larger area of the PV plant due to inhomogeneous irradiation or locally differing heat transfer become visible. These phenomena have to be carefully distinguished from optical effects. Singular spots, cells, substrings or module strings with elevated temperatures are a strong indication of faults. This temperature rise is linked on the one hand with heat generation on the other hand with electric losses.

Nevertheless, the solar park of Figure 2 has two irregularly heated, outstanding module strings, marked in the IR image. Presumably, these two module strings are not electrically connected to the inverter. In this case the absorbed solar energy is only converted to heat. For this reason these strings have a higher temperature than their neighbouring modules and are visible in the IR image. Typical temperature differences are 4 to 6K. The most reasonable explanation is that this module string is not connected to the converter or the electric connection is lost. The electric power output is zero. The consequence is a significant power loss.
