Corrosive effects of ammonia on PV modules and their evaluation

Urban Weber, Ralf Eiden, Thorsten Soegding & Kurt Nattermann, SCHOTT AG; & Harry Engelmann, SCHOTT Solar AG, Mainz, Germany

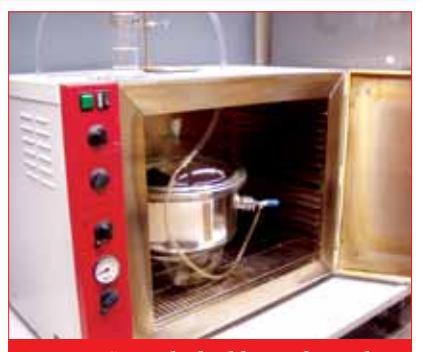
Figure 1. Setup for highly accelerated ammonia life test. The desiccator was filled with an ammonia solution designed to produce an ammonia concentration of 50,000ppm at 85°C, as well as various materials used in PV modules, such as glass/EVA laminates, cables etc. that do not come into contact with the liquid ammonia solution.

This study proceeded to determine the permeation of ammonia through a major encapsulant material (ethyl vinyl acetate, EVA) as well as a major back sheet material (Tedlar*/PET/Tedlar* (TPT)), allowing the evaluation of the temperature dependence. In order to identify the main damage mechanisms, PV modules were mounted in a test chamber with ammonia concentrations up to 2,000ppm in 70°C/70% relative humidity for a total duration of 840 hours. These PV modules were characterized together with a module from the roof of a pig pen which had been operating outdoors without problems for four years. Additionally, module components such as glass and encapsulation materials were stored in a highly accelerated ammonia life test, which consisted of ammonia concentrations of 50,000ppm at a temperature of $85^\circ\mathrm{C}$ and 100% relative humidity for a time of 84 hours (see Fig. 1).

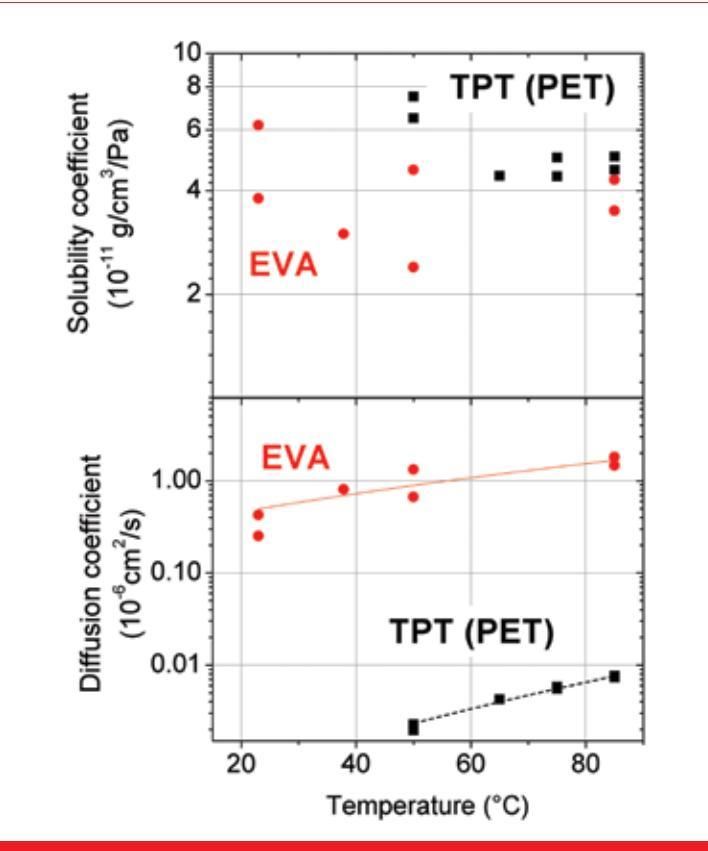
Figure 2. Diffusion and solubility coefficients of ammonia in EVA and TPT, with the latter evaluated as a single material. Graph lines are Arrhenius fits to the data (activation energies $E_A = 17.2 kJ/mol$ for the diffusion coefficient of EVA and $E_A = 32.5 kJ/mol$ for TPT (PET)).

Results of the diffusion and solubility constants of the two relevant polymer components are shown in the graph in Fig. 2. The solubility constants are similar for the two materials and depend only weakly on temperature. The diffusion constants are two orders of magnitude higher for EVA than for TPT. The ammonia ingress times into a PV module can be estimated from these data, according to the formula for the average range x_{av} of the entering gas:

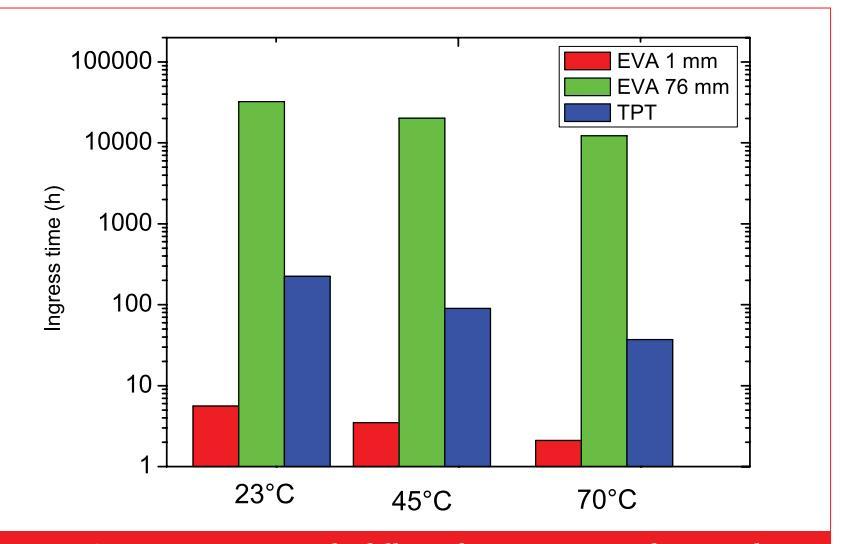
Figure 3. Ammonia ingress times for different distances in materials, extrapolating the value for TPT/PET at 23°C.

when *D* is the diffusion constant and *t* the time. Fig. 3 displays times for ingress into a typical PV module, where 1mm is representative of a typical EVA thickness, and 76mm is half the size of a 6" cell.

These data imply that in the field, ammonia penetrates the outer skin of an EVA/TPT PV module within a few days. Although it can take several years to reach the centre of the cells at the front side, corrosive effects – if present – can begin immediately after deployment near the rims of the cells. On the other hand, a test design for ammonia resistance should take the time lag into account (typically a few days) which can retard the ammonia action within the PV module.

Ammonia ingress times through the back sheet, however, do need to be considered. With respect to inner module components, a time lag of around 40 hours (DLG), 50-90 hours (test designs #2 and #3), or 170 hours (DIN 50916) has to be taken into account (cf. Fig. 3). For test design #5 (DIN 50916) in particular, this is a substantial fraction of the total test time, so a correct evaluation of degradation within the module is additionally impeded. As a consequence, the DIN 50916 test is clearly unsuitable for assessing the ammonia resistance of PV modules. In the DLG test design, sufficient time is given for ammonia to reach inner module components and to correctly assess their ammonia resistance.

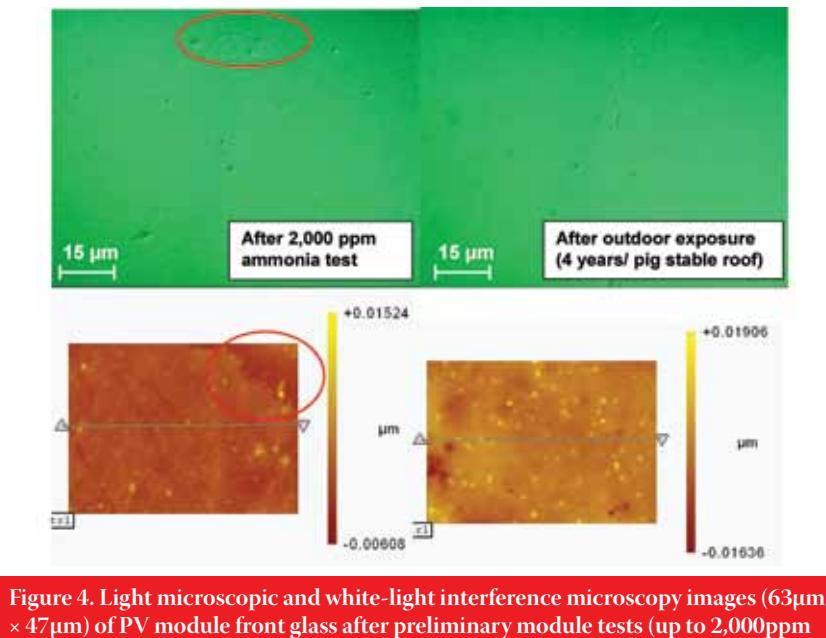
\times 47µm) of PV module front glass after preliminary module tests (up to 2,000ppm ammonia at 70% humidity and 70°C for 840 hours) and outdoor exposure (four years on top of a pig stable roof).

After ammonia tests with the modules, light microscopy and white-light interference microscopy of the front glass showed locally minor damage to the glass surface in the nm range (see Fig. 4). Modules that had undergone four years of outdoor exposure showed no such signs (see Fig. 4). The signs of glass corrosion were not unambiguous, however. The front glass was subjected to high ammonia load conditions (50,000ppm) which led to severe glass damage in the form of an extreme surface roughness and the formation of a film of crystallite-like particles which could not be wiped away using either water or ethanol (for details see [7]). These are typical signs of severe glass corrosion [8], which strongly suggests that this is an area of potential damage as a result of the presence of ammonia.

As the outdoor-exposed module from the pig stable did not show any signs of front-glass corrosion, realistic field conditions do not seem to implicate a significant damage of the module front glass. The situation is, however, very different in the case of antireflective-layercoated (ARC) front glasses, as the visual appearance of such modules could degrade much more severely due to glass corrosion.

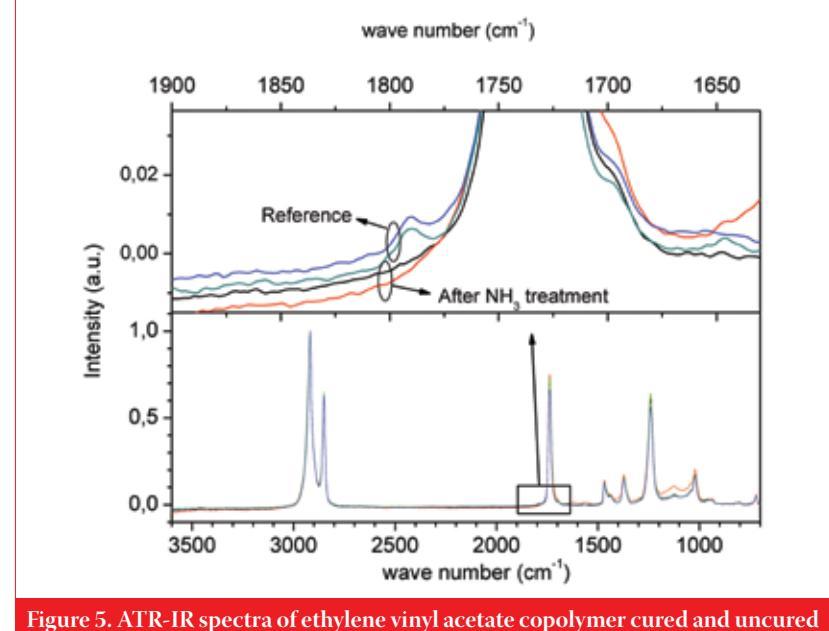
with and without a highly accelerated ammonia life test (50,000ppm ammonia).

Several polymer components of PV modules as used by SCHOTT Solar were subjected to highly accelerated ammonia life test (50,000ppm/85°C/100% relative humidity/84 hours). Attenuated-totalreflection infrared (ATR-IR) analysis of the respective materials did not show major degradation of any material investigated, which included cables, the junction box, adhesives and back-sheet materials. Minor modifications were noticed in the ethylene vinyl acetate copolymer used for encapsulation. As shown in Fig. 4, although the main peaks do not change, a small peak around 1,795cm⁻¹ disappears upon ammonia treatment, both for cured and for uncured material.

This peak is very likely a signature of the C=O double bond as it is shifted versus the main C=O peak of vinyl acetate $(1,735 \text{ cm}^{-1})$. As a result, the peak is assumed to be associated with an additive, possibly a peroxy esther which may be
